Manhole Inspection Summary

Manhole # S23KK1025MH

Insp Date: **11/21/06 9:18 AM**

Location Address: **4408 BUCHANAN AVE**

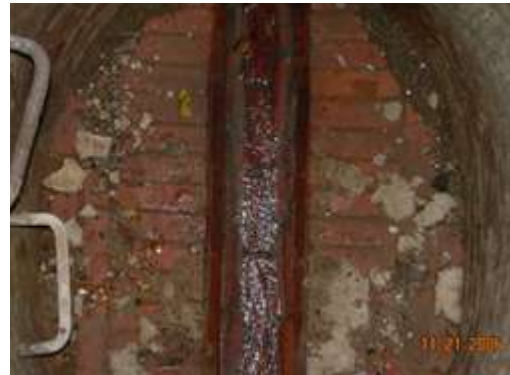
Top View

Bench debris.

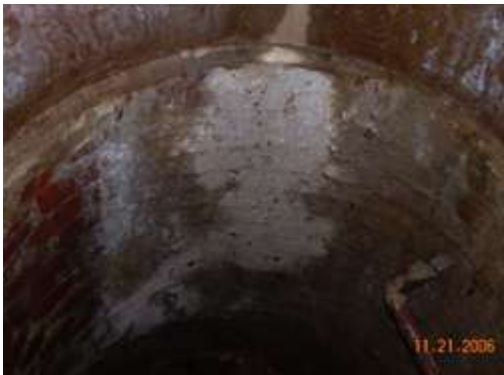
Defect

Frame Offset: **1** (in.) Condition: ☐ Sound ☐ Cracked ☒ **Leaks**

Infiltration: ☐ None ☒ **Joint** ☐ Cracks ☐ Mortar ☐ Roots ☐ Wall

Frame leaks. Adjustment and Corbel infiltration.

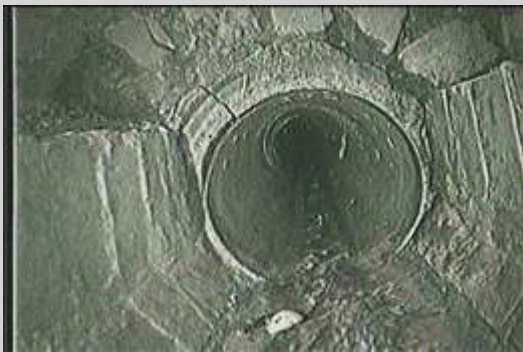
8 in. Circular Gravity Sewer Pipe Out @ 12 O'Clock

Infiltration: **None** Pipe Seal Cond: **Cracked**

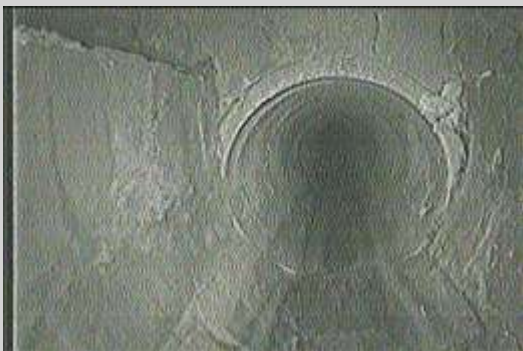
8 in. Circular Gravity Sewer Pipe In @ 6 O'Clock

Infiltration: **None** Pipe Seal Cond: **Cracked**
